## An Unappreciated Italianate Delight

*written by Dr. Les Crocker, Emeriti Professor of Art History  
January 2021*

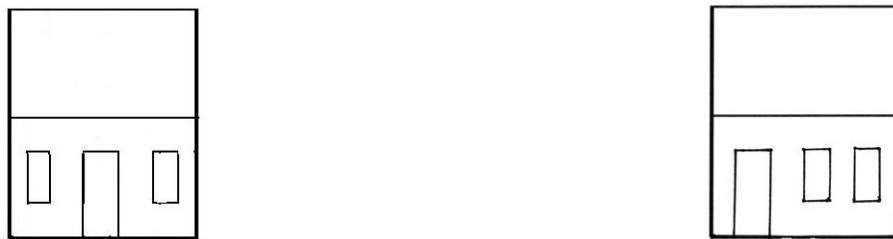
On the left, the entrance in the center bay of a three-bay structure is a balanced form more typical of Georgian, Neo Classical and many vernacular buildings. Having the entrance in bay 1 or 3 in a three-bay façade is Italianate and is shown on the right. Usually the door was a double door in the Italianate example. The main entrance was in bay one or three, almost never in the center bay. The entrance was usually in the bay furthest from the wing. There was a secondary entrance in the side wing.

In La Crosse the Italianate style brought in a major change in house plans. Early houses were usually rectangular, with a decorated front. After the Civil War the Italianate style brought in the use of 'wings,' sections of the house at a right angle to the main unit, usually on just one side, but occasionally on both. Probably the most common plan was a “three-bay front with offset entrance and secondary entrance in the wing on the opposite side from the main entrance.” Not a very catchy name but maybe someone else can come up with something better. A bay is any first floor opening – windows and doors are both considered to be a bay. A standard three-bay front then could be this arrangement shown here but the placement of the bays could vary.

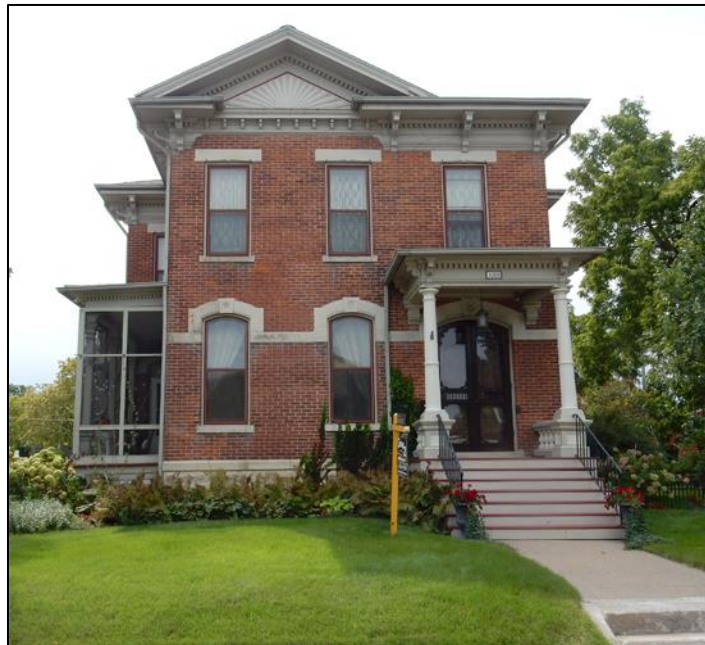
*The James and Agnes Vincent House at 1024 Cass Street.  
Photo taken by Dr. Les Crocker, 2020.*

The front presents itself as three bays wide with the entrance in the bay to the west. There was a secondary entrance in the wing for family and friends that didn't want to use the formal entrance.

This secondary entrance is now obscured by a screen porch probably added in the early twentieth century. The house sits on a raised basement which means there must be steps to get to the front door.

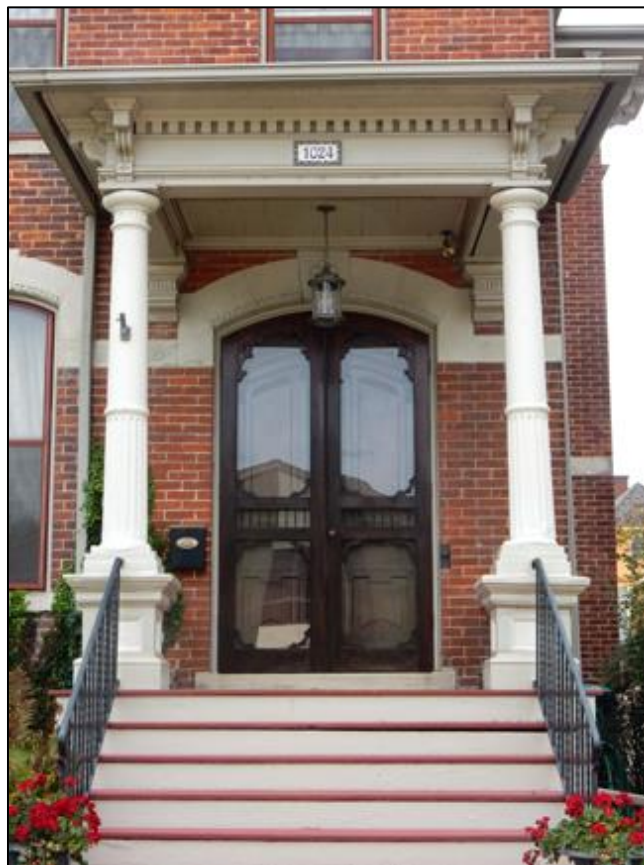
A raised basement gives a house more authority, more importance. A single bay porch is at the top of the steps, providing cover for visitors. Most houses of this type had front porches but none as grand as the Vincent house. Two columns carry the weight of the porch roof. The capitals are pillow shaped like the very early Greek Doric columns. Beneath the capitals are a short section of fluted column, then a simple rolled molding. Beneath that, the column is plain until we reach another rolled molding, proportionately larger than the upper one. Another section of fluted column rests on a molded base.

The entire column stands on four blocks to spread its supposed weight. The blocks rest on an elaborate pedestal with a three-part molding, a section with inset panels, and a plain base. The pedestal is joined to a thick porch railing supported on vase shaped balusters that hadn't been used in American houses for over a hundred and fifty years.

*Front entrance detail. Photo taken by Dr. Les Crocker, 2020.*

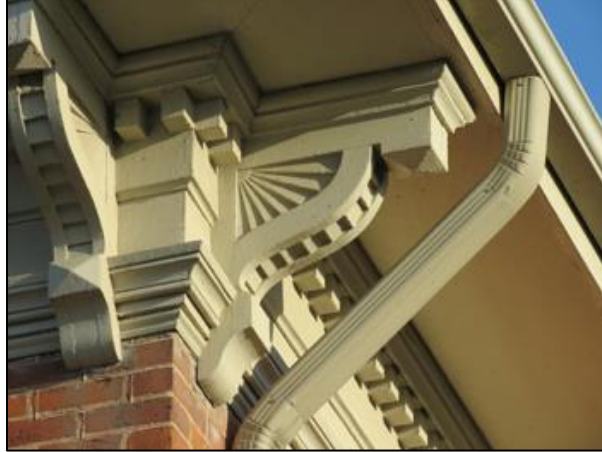
The columns support a cornice with a simple base molding, a plain frieze and a cornice of dentel blocks. A bracket, strong in appearance but not massive, is centered over the column on two sides.

*Bracket detail on a corner of the house. Photo taken by Anita Taylor Doering, 2019.*

Brackets got larger and larger in the Italianate style and became a defining element of the style. While the outer end of the porch roof is supported on the two columns the house end of the porch roof is carried on two elaborate corbels extending from the brick wall. Italianate houses almost always have double leaf front doors, with panel moldings. Mr. Vincent had access to any locally grown wood that he wanted and his doors are thick with fine molding.

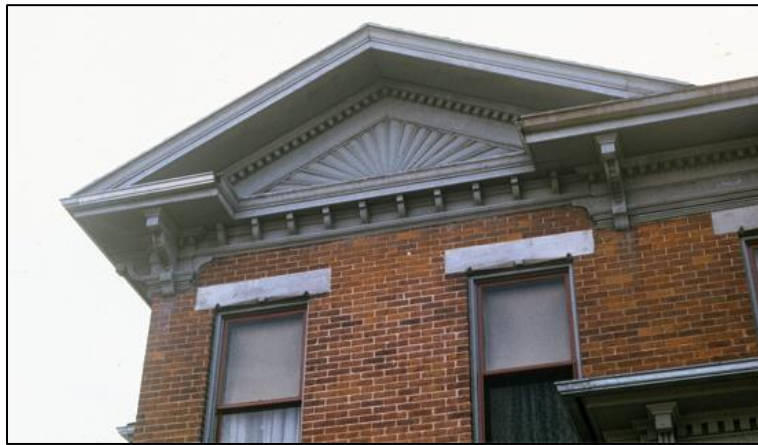
*Looking up we see the same arrangement of forms in the roof cornice.  
Photo taken by Dr. Les Crocker, 2020.*

The brackets are larger because the cornice is deeper, everything is in proportion. Above the two front bays, not part of the entrance, is a classical pediment with cornice returns, the horizontal sections across the bottom of the pediment but unconnected. The central section of the pediment displays a rising sun motif, unusual in the Italianate style but more common in the Queen Anne style.

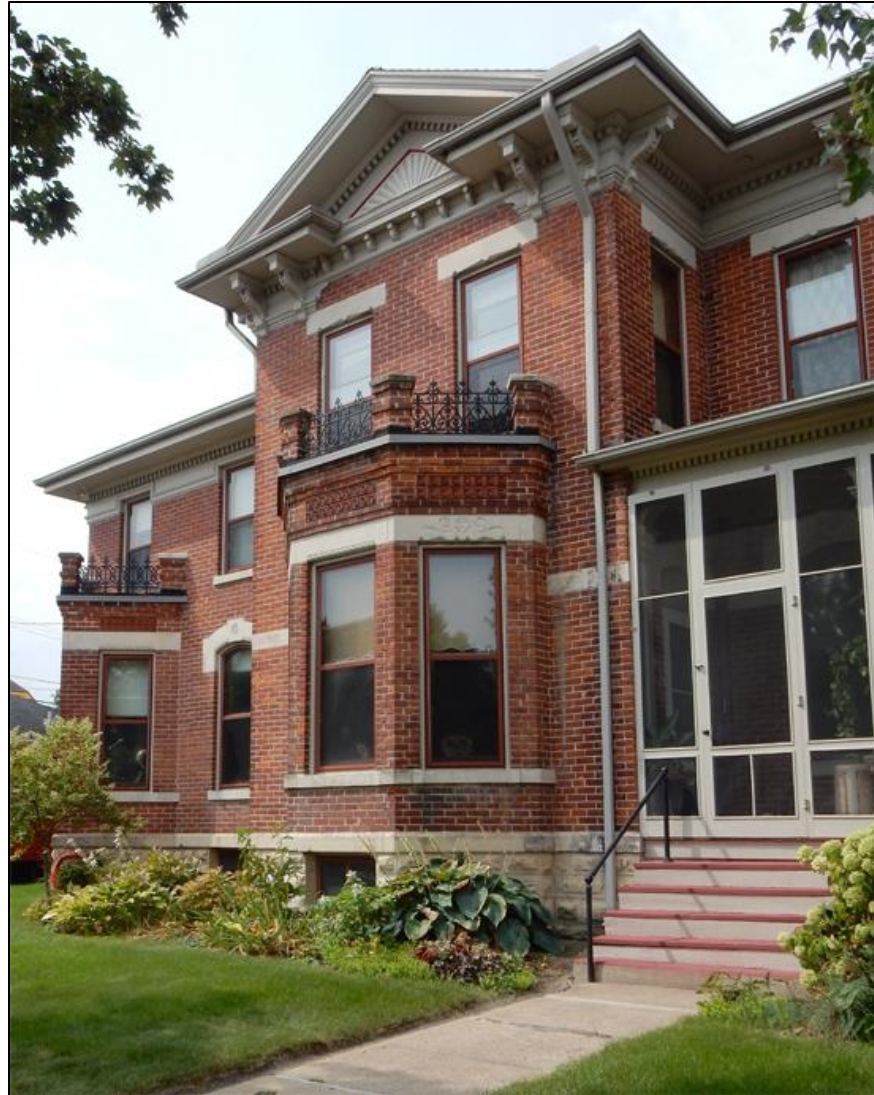
*The side facing 11th Street. Photo taken by Dr. Les Crocker, 2020.*

The main block of the house is a rectangle but an extension, called a ‘wing’ in the nineteenth century, breaks the rectangle. Not only is this wing interesting for its decoration it allows extra windows on three sides for better air circulation and is the location of the secondary, or family, entrance. This side of the house has two marvelous bay windows as well.

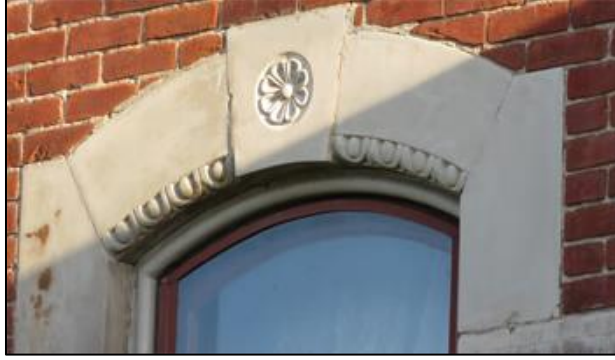
*Upper window head detail. Photo taken by Anita Taylor Doering, 2019.*

The sills of the bay windows form a continuous line that echoes the thicker window heads, decorated by an open flower flanked by vine like shapes on the two side window heads while the central window head has a simple egg and dart carving on its lower edge. Above the white widow heads the brickwork resumes with two courses that overhang the one below. This creates shadow lines that give the brick more definition. The overhanging brick frames two rows of terra cotta plaques with spiral motifs. Terra cotta is a red clay that is exceptionally hard when fired and allows sharp detail when carved.

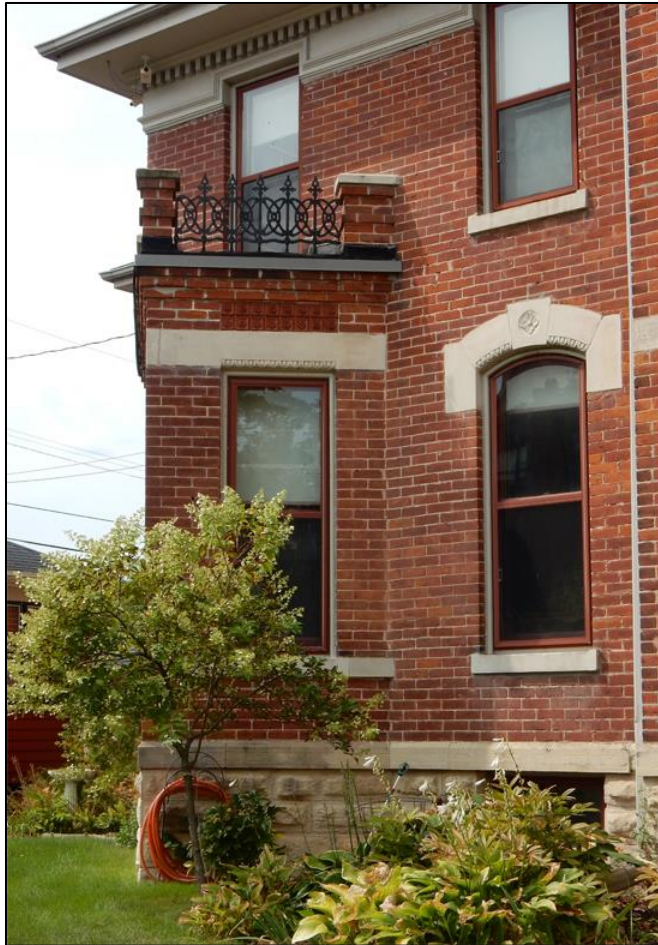
*The two-sided bay window. Photo taken by Dr. Les Crocker, 2020.*

Above the terra cotta the brick courses alternate their depth to vary the surface. A thin limestone band caps the top of the bay window. Above this cap are four short brick pedestals with courses of varied depth and capped with a limestone block. The pedestals are linked with some of the earliest examples of decorative ironwork remaining in the city.

Further south on this east wall is a two-sided bay window that echoes all the features of the larger, three-sided bay window but with a different design in the ironwork balustrade. These bay windows not only break the monotony of the brick wall and create better ventilation, they were great places for indoor plants which were quite popular at the time.

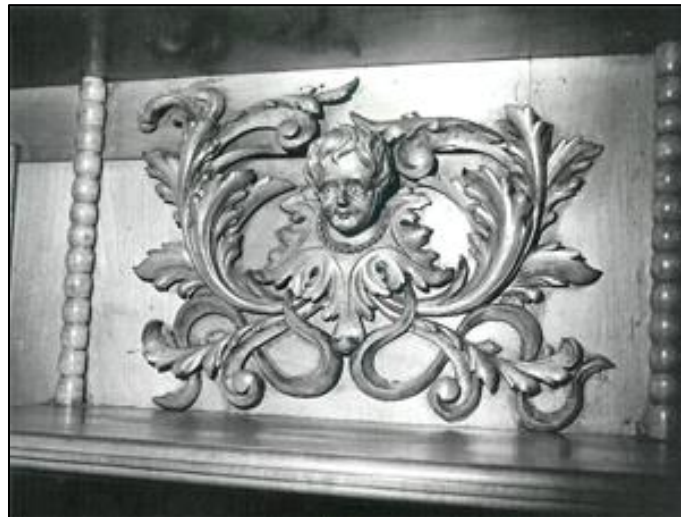
*Carving detail by Ori Sorensen of the Egid Hackner Altar Company.  
Photo taken by Don Sutor, 1980.*

On the interior he commissioned one-of-a-kind, built-in furniture with carvings done by Ori Sorensen from the Egid Hackner company. His bathroom had one of the earliest indoor toilets and the bath tub, along with the one in the Hixon house, is one of the two early examples remaining in town. But that is another story. Today we are too busy to notice detail. Television blasts our eyes and minds with an ever-changing montage of images. The Vincent house is from a time that appreciated good proportions and delightful detail. It is a most unappreciated home.
